**HISTORICAL REPORT**

**DET #3 SITE ACTIVATION TASK FORCE**

**BEALE AF BASE, CALIFORNIA**

HISTORY  
OF  
CORPS OF ENGINEERS  
ACTIVITIES  
AT  
BEALE AIR FORCE BASE

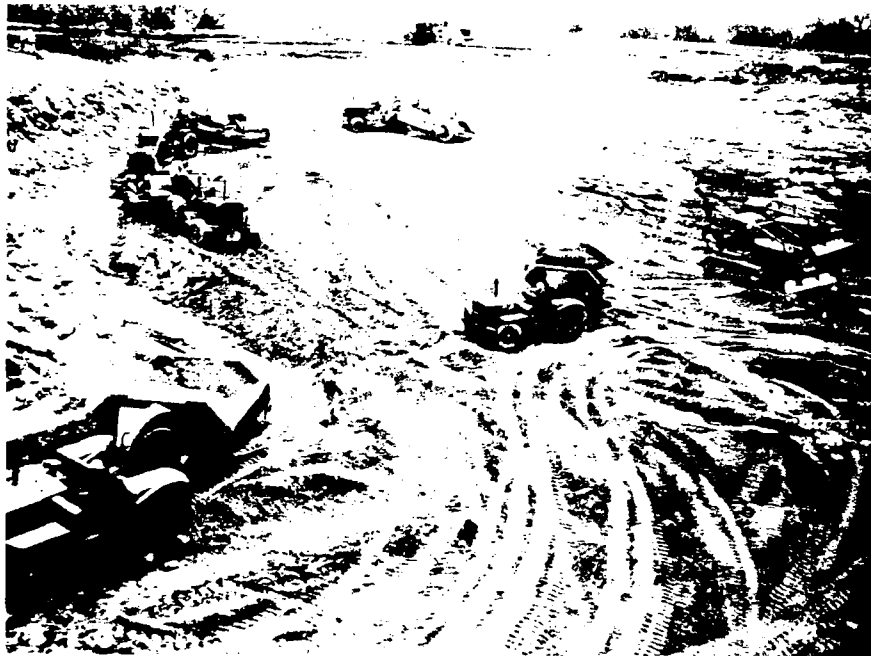
Fig. 12

Excavation of Launcher #1, Site 1A

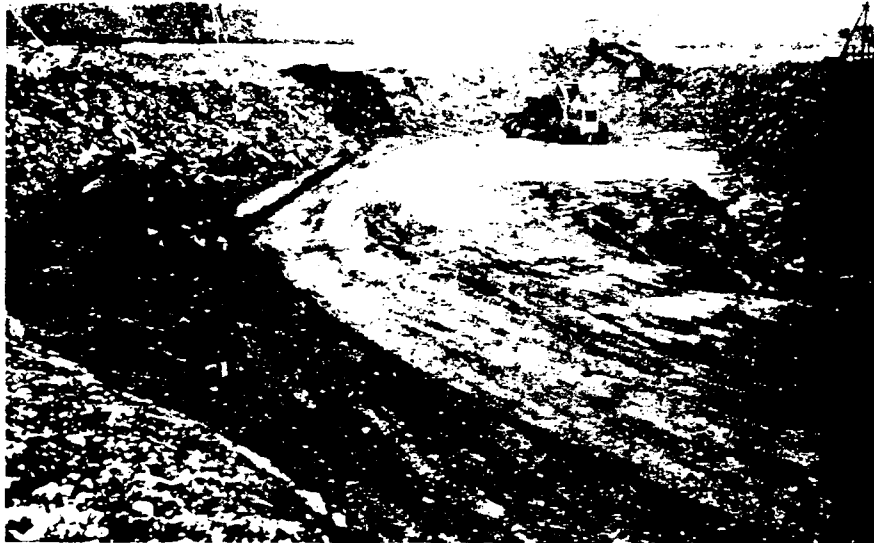
Fig. 14

Open Cut Excavation Showing Huff Loader,  
Launcher #2, Site 1C

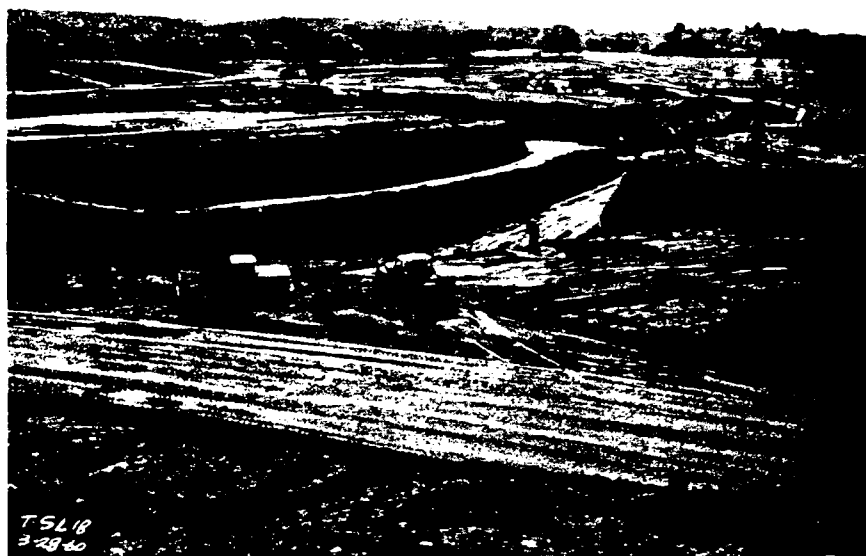
Fig. 17

Open Cut Excavation Showing Berm,  
Launcher #2, Site 1A

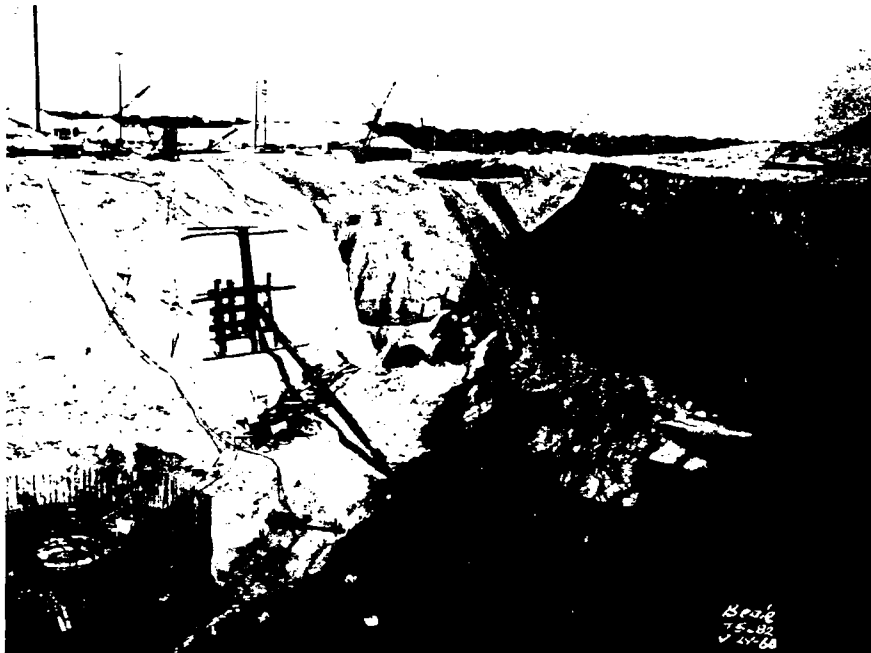
Fig. 18

Antenna Silos Open Cut Excavation,  
Shoring of Slope, Site 1A

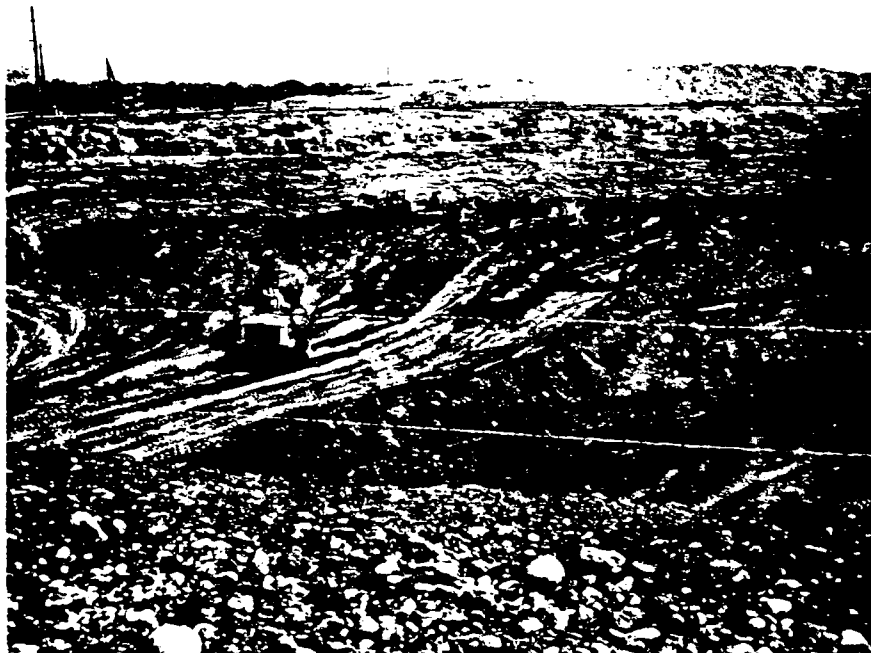
Fig. 19

Open Cut Excavation of Powerhouse,  
Control Center Showing Lava Cap, Site 1C

At Site 1C a muddy condition existed which slowed excavation until pioneering had been accomplished. The removal of the lava cap, approximately 6 feet below existing ground surface and approximately 12 feet in depth required drilling and blasting. Approximately 150,000 cubic yards of rock was removed. Below the lava cap to bottom of open cut excavation, no unusual problems occurred. (See Figure 19 ) There was no sloughing of the cut slopes.

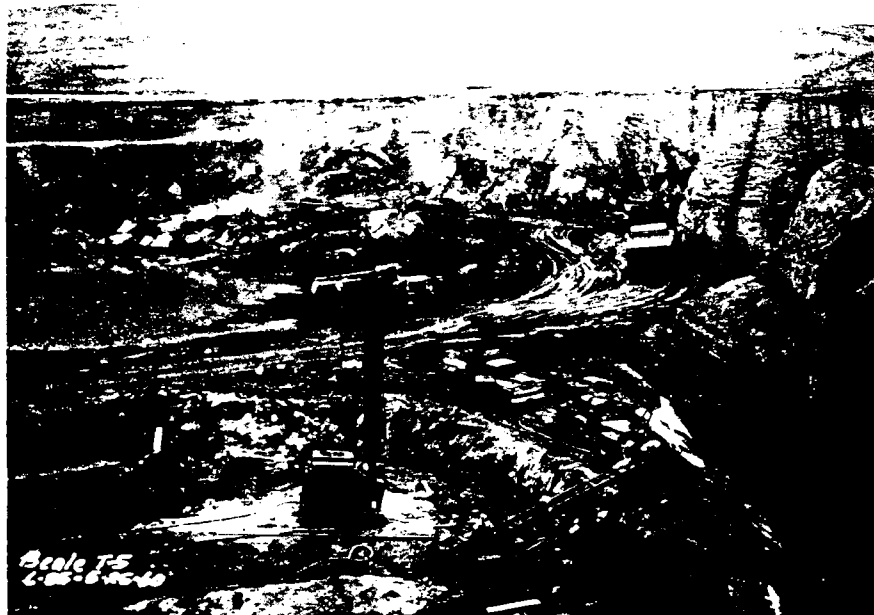
Fig. 21

Rock Bolt Hole Drilling, Site 1A

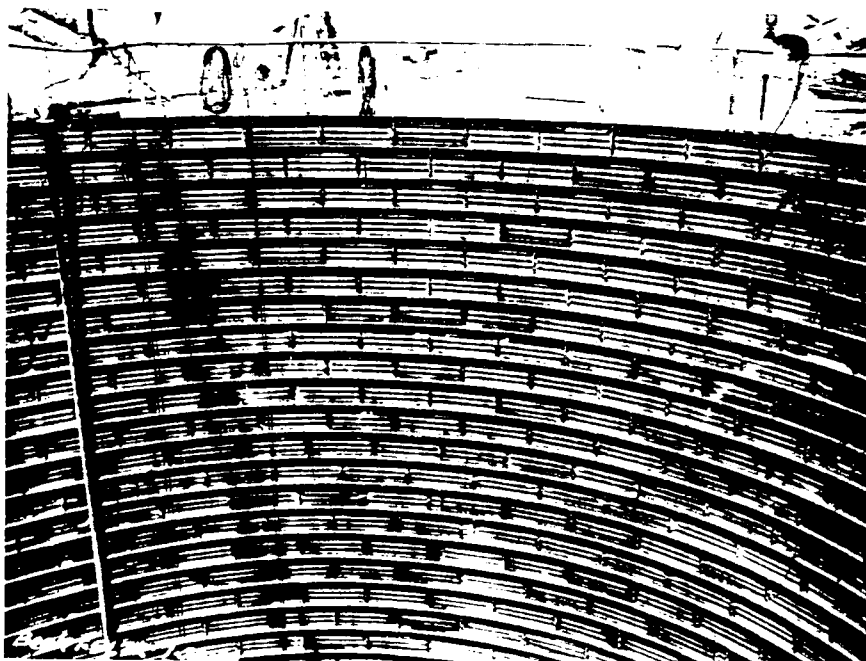
Fig. 23  
Liner Plate, Missile Silo #2, Site 1A

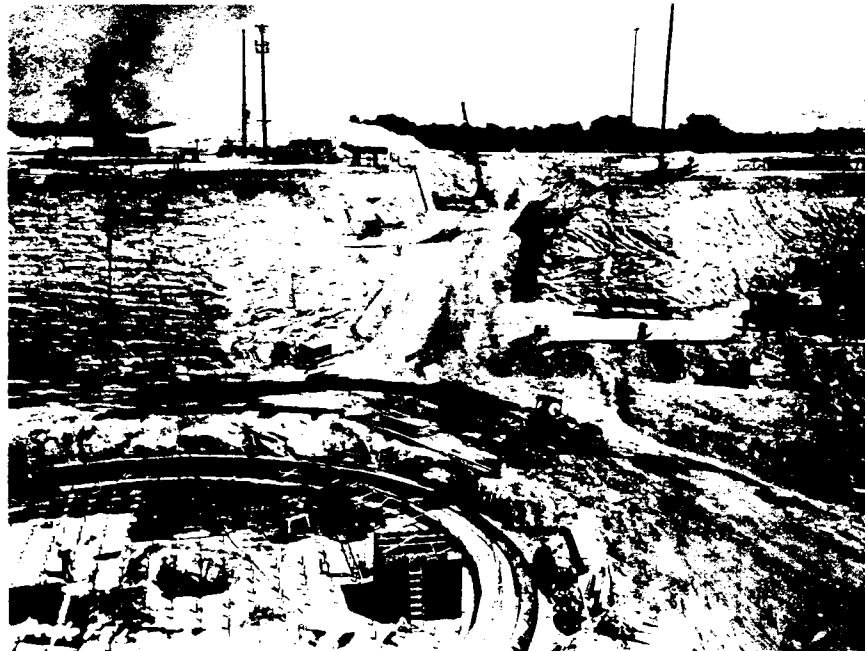
Fig. 25

Rock Bolts, Control Center, Site 1A

adequate anchoring of the rock bolts. At Site 1A rock bolts were required to anchor the foundation slabs of all other structures in order to compensate for hydrostatic pressure. (See Figures 24 and 25 and 26 ) In the Missile Silo, one hundred rock bolts were required. These were 2 3/4" round bolts, 28 feet 6 inches long, 27 feet of which were grouted into the hole with non-shrink grout. The end embedded into the concrete had upset end to 3" diameter. Rock bolts for other structures were 2" round bolt, with lengths of 22', 23' 6" or 28' 6". (See Figure 27) All rock bolts were threaded at each end. The bottom nut was tack welded and at top end washers were used with the nut.

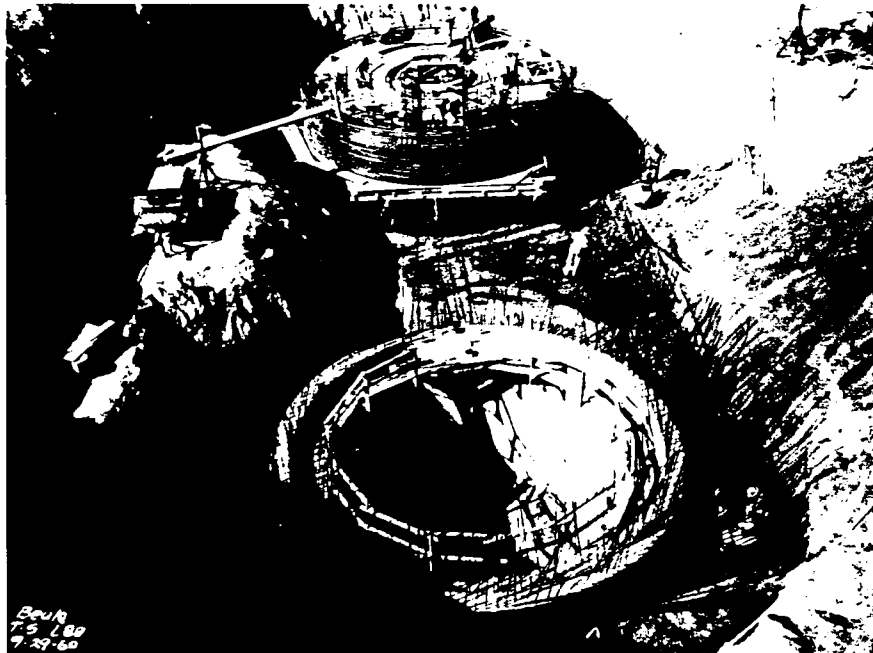
Fig. 29

Compacting Backfill Antenna Silos, Site 1A

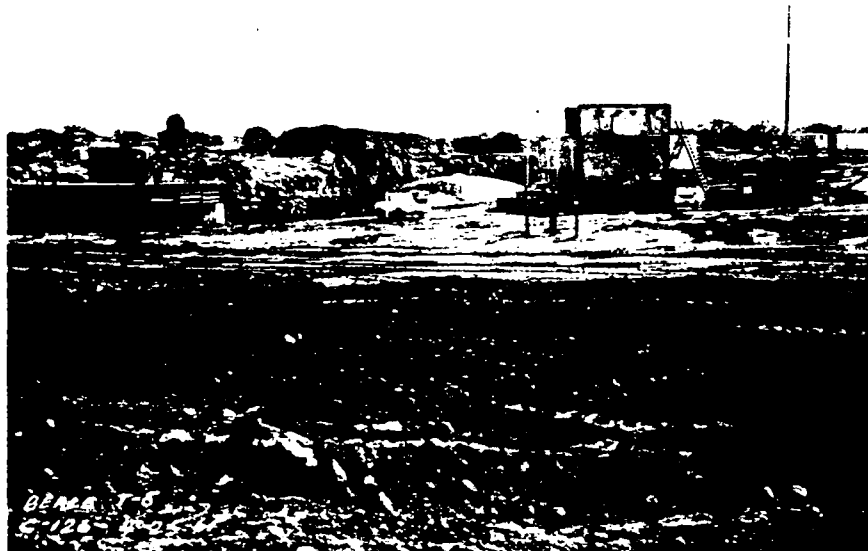
Fig. 30

Backfill Showing Rock, Site 1C

At Site 1C the quantity of rock excavated from the open cut excavation was much greater than that excavated at Sites 1A and 1B. Much of this rock was utilized in the backfill.

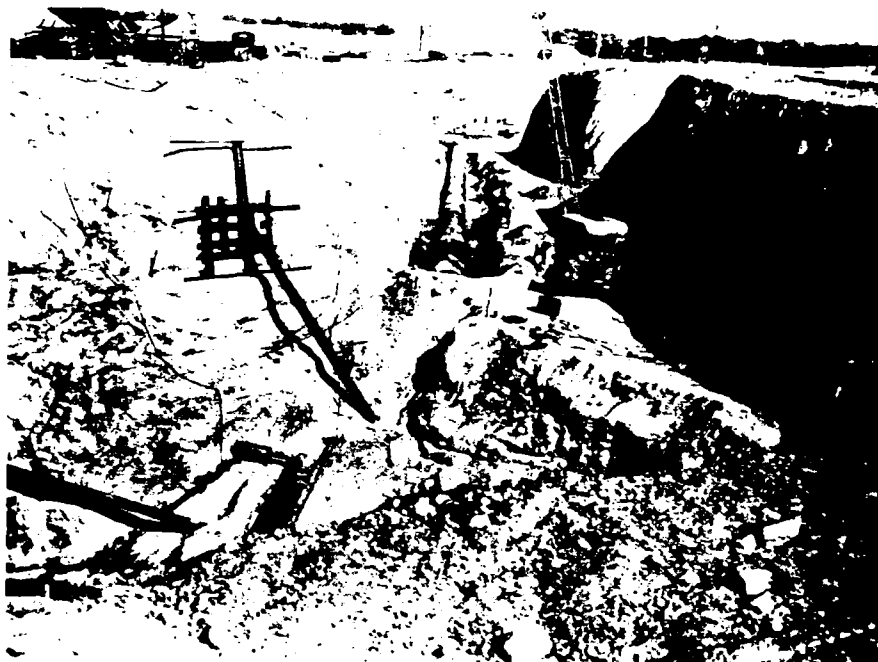
Fig. 32

Tunnel Backfill, Site 1A

The specification requirements for tunnel backfill were waived at Sites 1A and 1B, in that at Site 1A (See Figures 31 and 32 ) sand backfill was used underneath and up to spring line and at Site 1B, because of the suitability of the granular material, sand was not used. Specifications required that sand be backfilled beneath, above and on each side of structures.

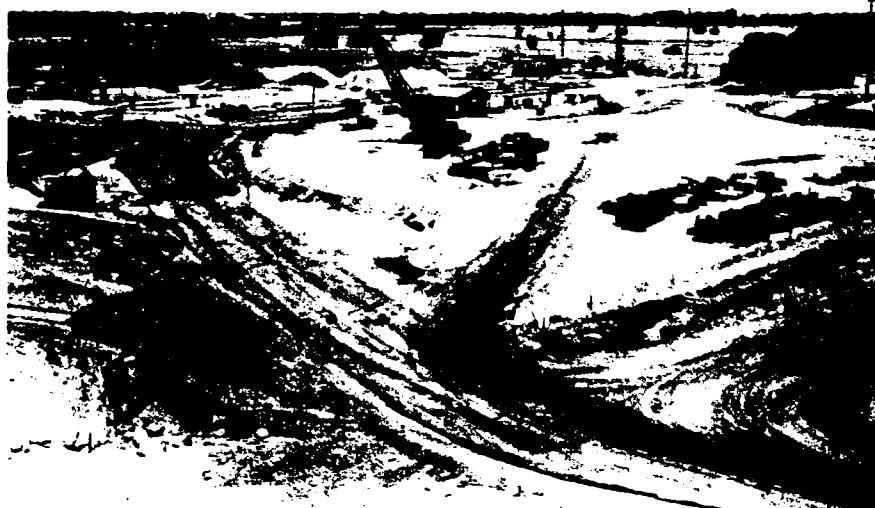
Fig. 33

Concrete Batch Plant, Site 1A

Cement	4.99 sacks/cu.yd.
Sand	33% by volume
Gravel	67% by volume
Air	4.0% by volume
Water	5.5 gal/sack

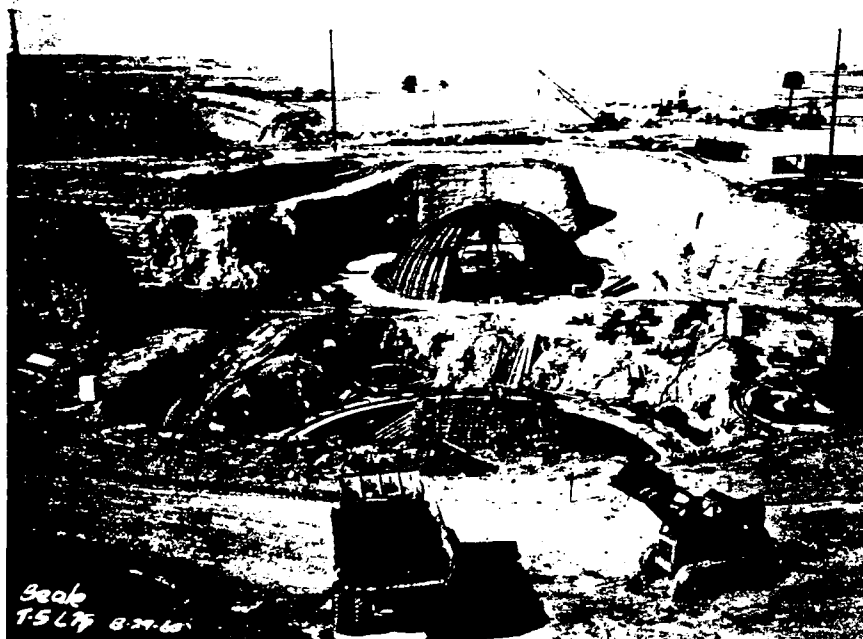
Fig. 41

Movable Steel Forms, Control Center, Site 1A

The forms for the Control Center and the Power House domes were movable steel forms. (See Figures 41, 42 and 43)

For each structure, there were two opposed orange peel forms 1/8 of the diameter of the structure, mounted on track and supported by structural members to center pivot post. (See Figures 42 and 43) Concrete placement was made simultaneously in each form, and forms were moved at same time. These forms first

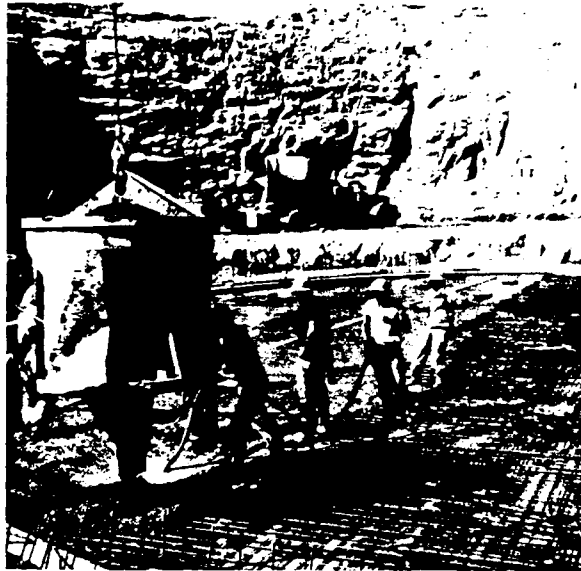
Concrete Placement Showing Concrete Buckets, Site 1A Fig. 58  
Control Center Foundation Slab

With the exception of the slip form operations and Power House foundation slab pours, cranes were utilized in placing concrete. (See Figures 57 and 58)

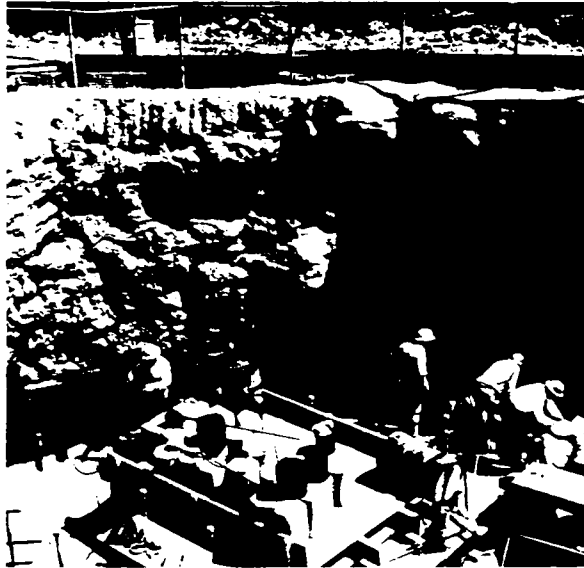
Fig. 61  
Waterproofing, Site 1A, Propellant Terminal Footing

Because of the seepage water conditions at Site 1A, all concrete structures were waterproofed. (See Figure 61) At Sites 1B and 1C the structures were dampproofed. The waterproofing and dampproofing operations proceeded exceptionally well and only minor problems were encountered. An asphalt primer was applied for both the dampproofing and the waterproofing. Two coats of hot asphalt were applied for the dampproofing. (See Figure 62 ) For waterproofing, five ply of thermoplastic bitumen treated fibrous glass membrane was applied with hot asphalt and protected on outside surfaces by fiber board. Inside foundation surfaces were protected by grout. Rock bolts were waterproofed with sealant. (See Figure 63)

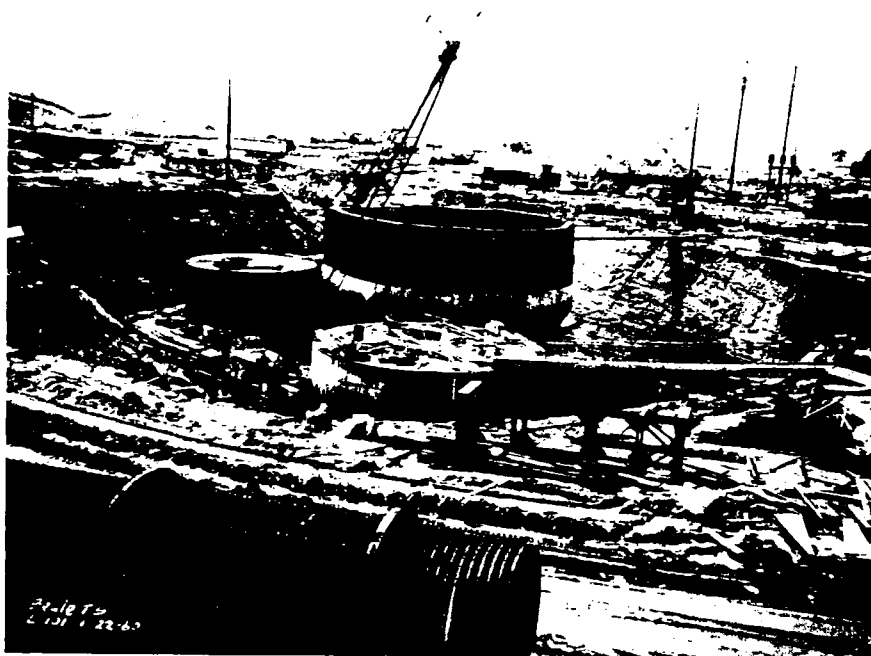
Steel Tunnel Section Showing Ring Beams, Site 1A Fig. 74

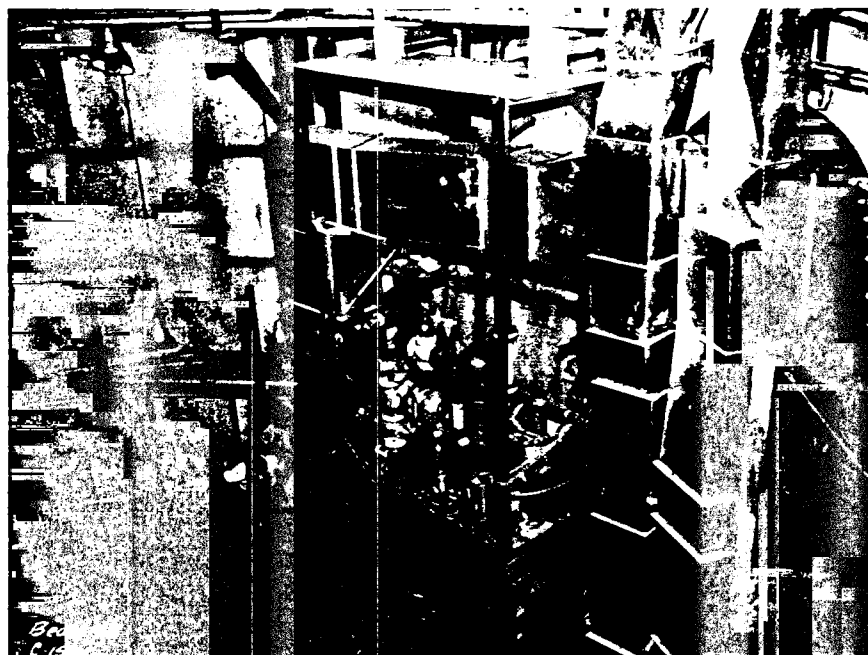
Fig. 85

Fuel Crib, Missile Silo (RP-1 flow controller and air release tank installation)

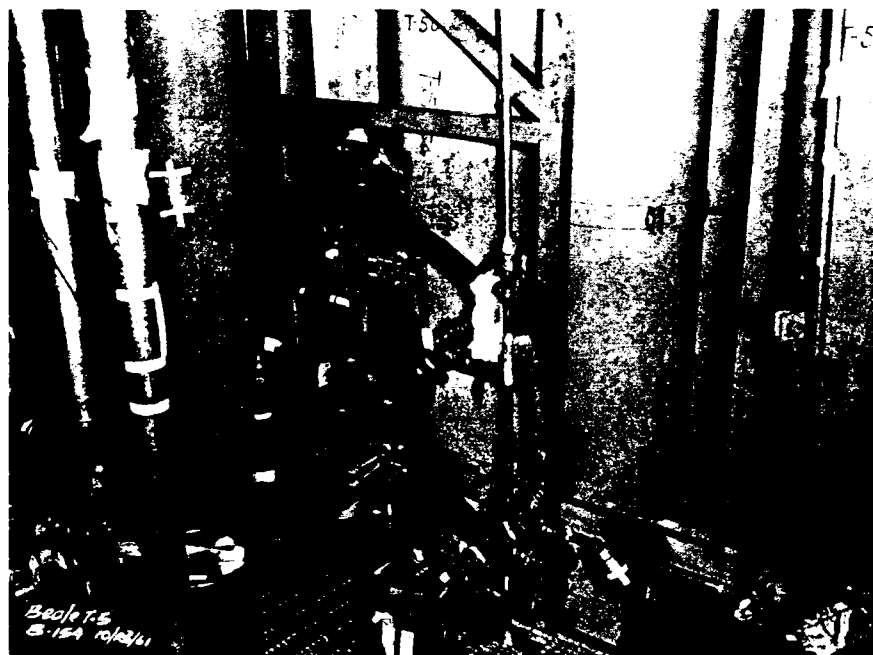
Fig. 96  
 Propellant Terminal, High Pressure Gaseous Bottle Cluster and Control Manifold

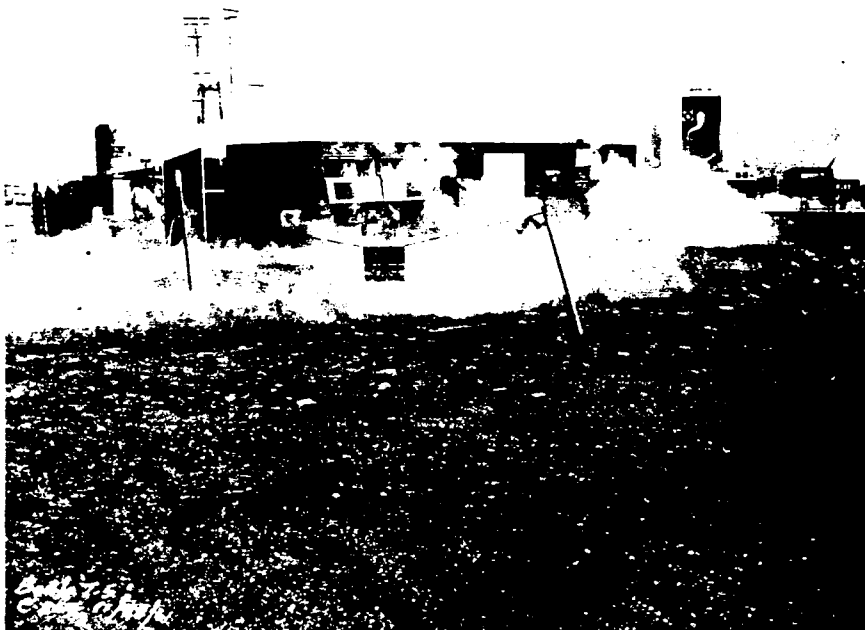
Fig. 98  
PLS Testing Equipment (High Pressure Recharger and  
Liquid Nitrogen Storage Tank)

The equipment furnished provided the necessary quantities required for the testing program. All equipment performed satisfactorily except for the liquid filters. The problems encountered with the filters were discussed previously in connection with the Government furnished liquids.
